OHIO HISTORIC INVENTORY

1. No. <u>MIA-423-02</u> <u>10927-004130</u>		4. Present Name(s) <u>108 N. Hyatt</u>	
County <u>Miami</u>		5. Other Name(s)	
3. Location of Negatives <u>Regional Office 5 HA</u>

6. Specific Location <u>108 N. Hyatt St.</u>		16. Thematic Category <u>C</u>	
7. City or Town If Rural, Township & Vicinity <u>Tipp City Monroe</u>		17. Date(s) or Period <u>c1870</u>

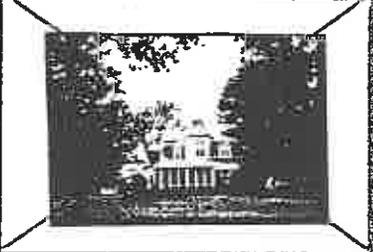
15. Name of Established District			
42. Further Description of Important Features <p>Screened-in porch across with balcony with cresting on porch roof. Multi-paned window at side right. Second floor windows 1/1 dhs. Central pavillion with mansard roof with bullseye window on all sides and cresting on top. Smaller mansards, each with a dormer with window and bracketed eaves. Right rear chimney.</p>

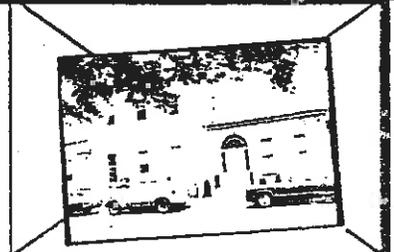
42. Further Description of Important Features
Original front entry removed and now at side right. Entry has fanlight transom with mullions and 2 rows of radiating voussoirs. Sidelights with tracery. All windows with stone lintels and lugsills. Original windows on first story are 9/6 dhs and 6/6 dhs on second story. Some windows boarded in original sections. New cornice added across roof line. Loading dock on north side. Projecting eaves on roof.

Built in 1869 as the Ford Wheel Works Co. to make oak buggy wheels. Later used as a factory by the Tipp Furniture Co.

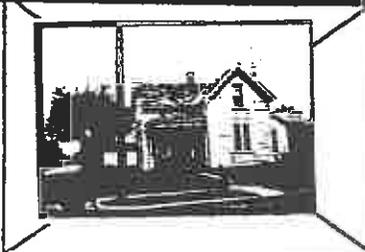
42. Further Description of Important Features
Windows are 4/4 dhs down and 6/6 on second story with shaped wooden architraves. Porch on left side of facade. Gable on front with vergeboard trim. Brackets on roof line. Center chimney.

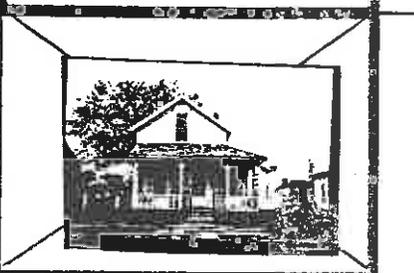
42. Further Description of Important Features
 Advancing pavillion with entry side left and side right. Windows are 1/1 dhs with architraves. Porch is of interest with its turned posts, brackets and pendants. Smaller windows on second story. Addition with shed roof at rear and addition at south side of the house. Two doors at south side. Center chimney.

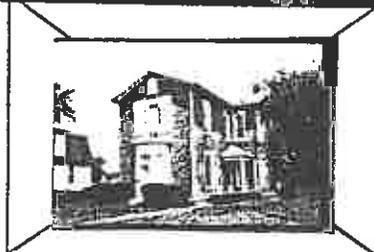
41. Distance from and Frontage on Road 25' back, 80' wide
42. Further Description of Important Features Stone foundation with water table. Advancing central pavillion with bay with full entablature. Central door in bay has glass transom with muntins & sidelights. Window above 6/9 dhs with small windows on either side and blinds. A common stone lintel for the three windows. Semi-circular window in peak of gable with stone label with keystone & blinds. All side windows 6/6 dhs with stone lugsills.

43. History and Significance This once elegant home is reminiscent of an earlier era of prestigious homes. Servants quarters at the rear is also in excellent repair. Built for Levi Clark, the house was constructed of double brick throughout because his wife was afraid of storms.

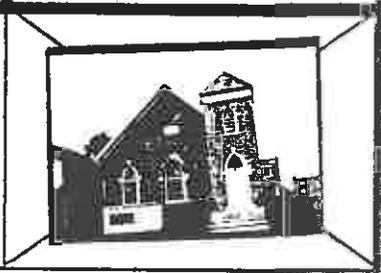
42. Further Description of Important Features
New facade with quarrelling at top of gable. Two pointed arch stained glass windows with double row of radiating voussoirs and keystones. Similar window above door in bell tower at side right. The bell tower has been added to the church--it has a decorated frieze and finial at top. House at rear has been connected and wooden belfry removed.
